RELAY REPLACEMENT INSTRUCTIONS

Telephone 920-682-0161, Fax - Sales: 920-683-7589, Service/Parts: 920-683-7585, Other: 920-683-7879
Web Site - www.manitowocice.com
8014483
07/29/03

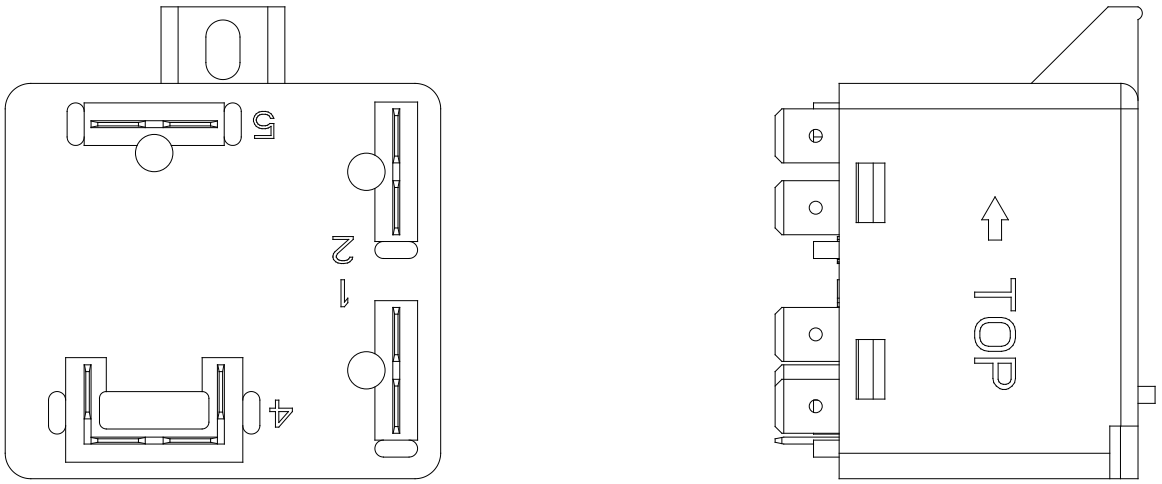
Correct Orientation

1. The Electrica relay will not function properly unless it is mounted in the correct orientation. Refer to label affixed to relay.

2. Insulated wire terminals will not fit properly on Electrica relay.

3. Wire harnesses with insulated terminals can only be used in conjunction with the non-insulated duplex ("piggyback") terminal provided.
